## Eurasian Watermilfoil Management Program and Water Quality Summary for White Bear Lake, Washington County, Minnesota, 2019

Prepared for:  
White Bear Lake  
Conservation District

Prepared by:  
Steve McComas  
Blue Water Science  
St. Paul, MN 55116

November 2019

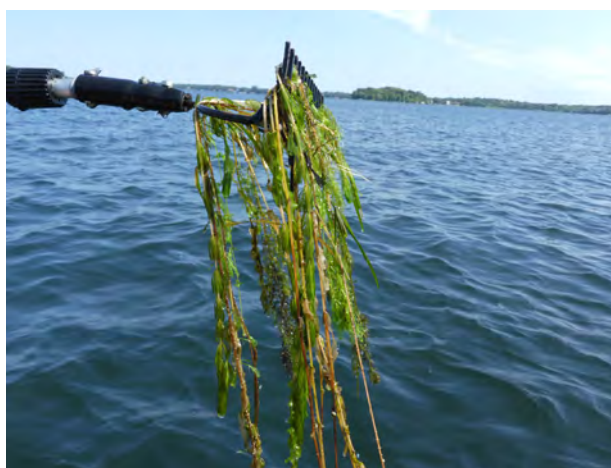
**Figure 3. [left] Mike Parenteau, White Bear Lake resident, helped with a survey in 2019. [right] Aquatic plants sampled on August 7, 2019.**

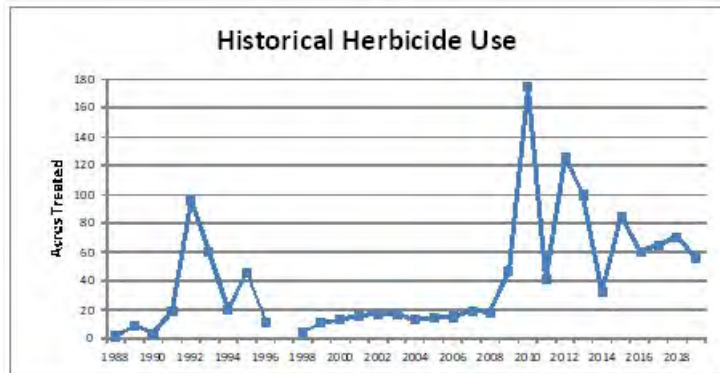
Eurasian watermilfoil was first observed with a single plant collected near a public dock on the west side of the lake in 1988. A history of Eurasian watermilfoil control measures is shown in Table 2. From 1991 through 1995, an aggressive EWM treatment program was implemented to try to stop the spread of EWM within White Bear Lake. The aggressive treatment approaches were discontinued after 1995. EWM had basically spread around White Bear Lake at mostly light to moderate growth with some patches of heavier growth. After 1995, there was a period of 13 years (1996-2008) where Eurasian watermilfoil treatments were less than 20 acres per year (which includes shoreline treatments). Since 2009, Eurasian watermilfoil has been more abundant and is reflected in an increase in treatment acreages. A graph of treatment areas from 1988 through 2019 is shown in Figure 5.

**Figure 5. Historical herbicide use in White Bear Lake from 1988 to 2019.**

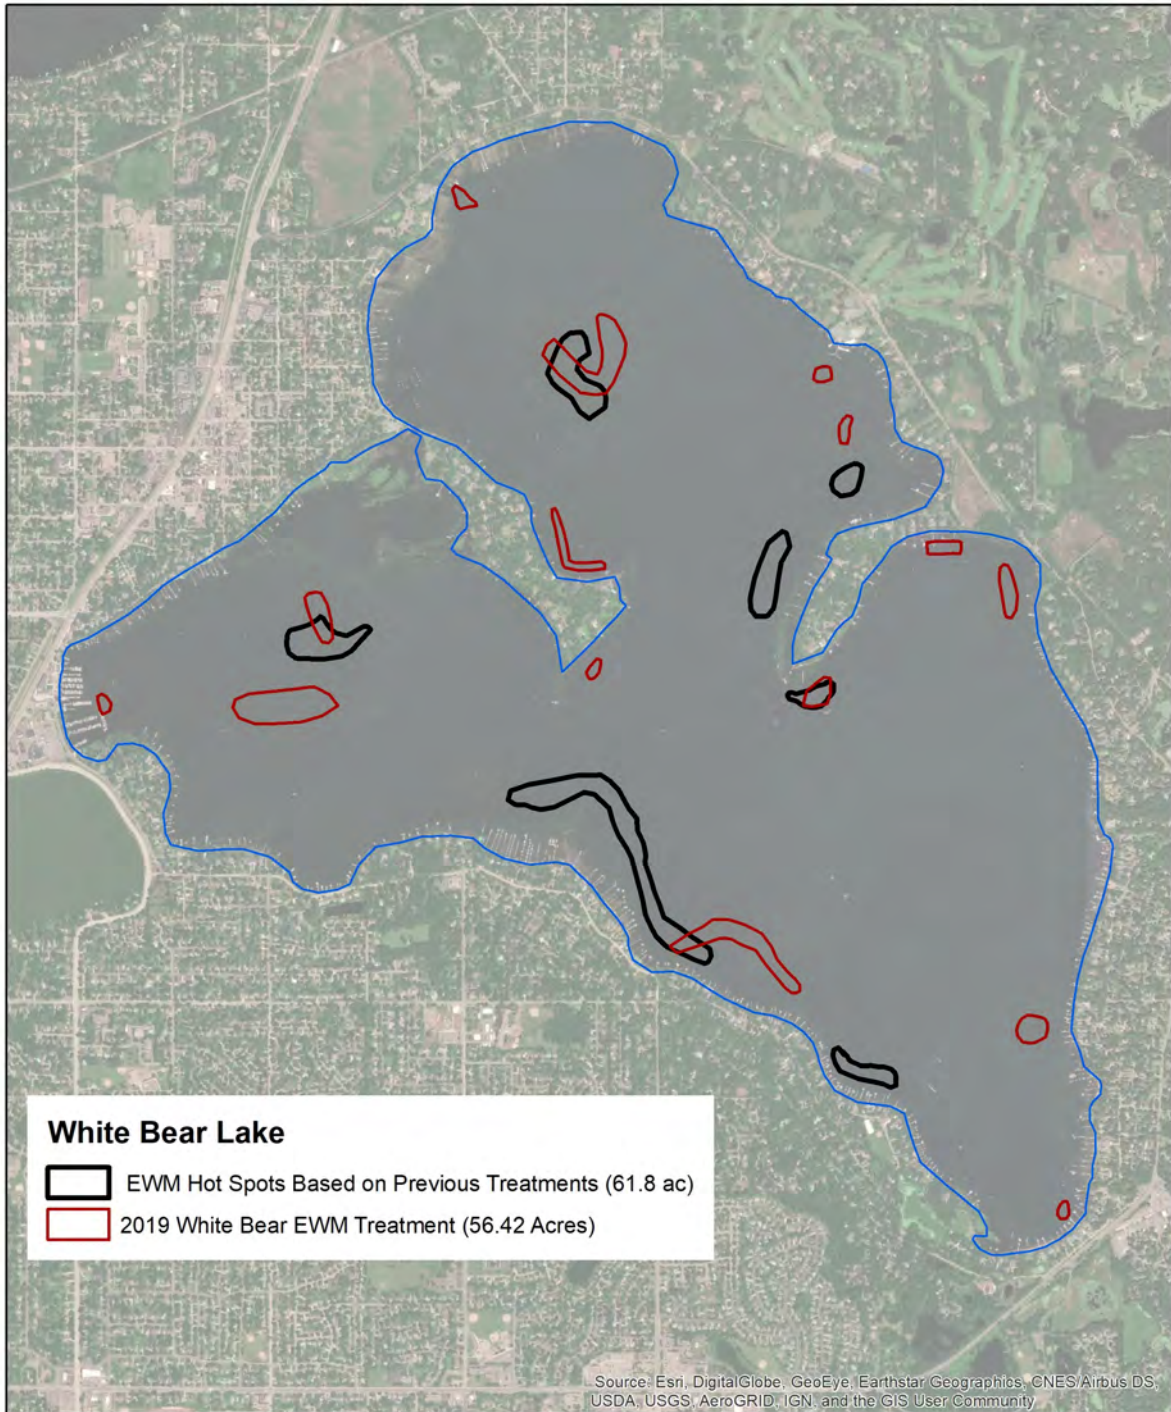
Figure 7. Overlay of 2019 treatment polygons and the treatment hotspots from 2012-2019.

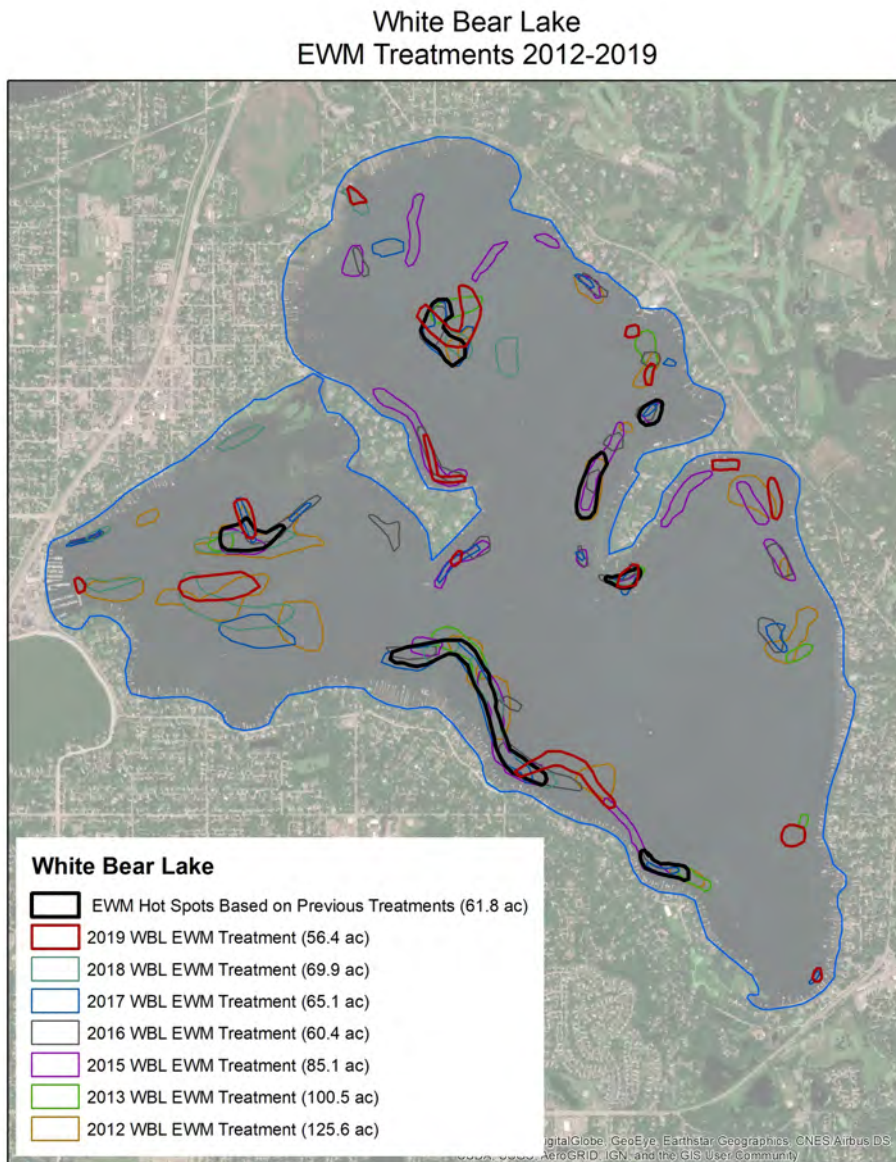
Areas of persistent growth and potential treatment are shown in Figure 8. These areas have been treated at least 4 out of the last 7 years. A MnDNR permit application for these areas would be submitted in winter. Then EWM would be checked in late May or early June to verify its presence. If it is present in the polygon then that area would be treated.

Figure 8. Proposed 2020 EWM treatment.

For EWM control in 2020 it is proposed to treat the persistent heavy growth areas early and then delineate the lake again in June to determine if additional areas of EWM treatment are needed.

There would be a EWM assessment in August or September to assess EWM control.

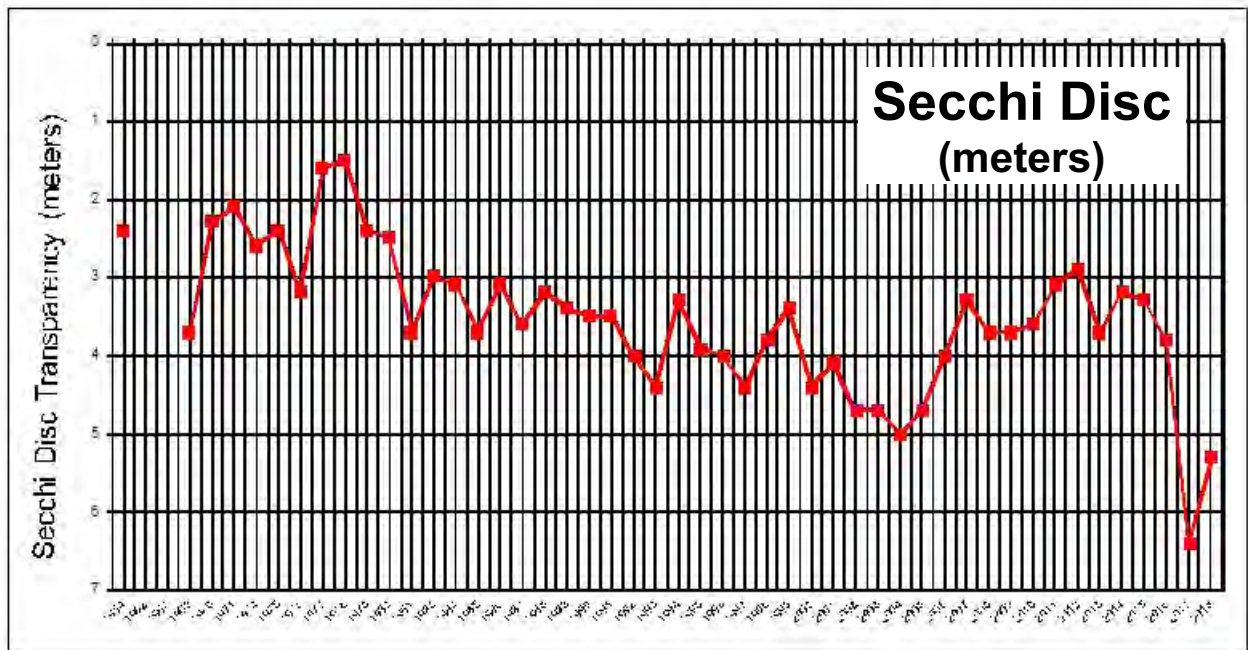
**White Bear Lake Water Clarity and Lake Levels Through 2018:** Secchi disc readings for 1969 through 2018 are shown in Figure 9. From 2007 through 2016, water clarity was not as good compared to the period of 2000 through 2006. Lake water levels have fluctuated over the years (Figure 10).

Figure 9. Secchi disc summer averages (from May-September, unless data are lacking) for White Bear Lake (2005-2018 data are from Ramsey County).

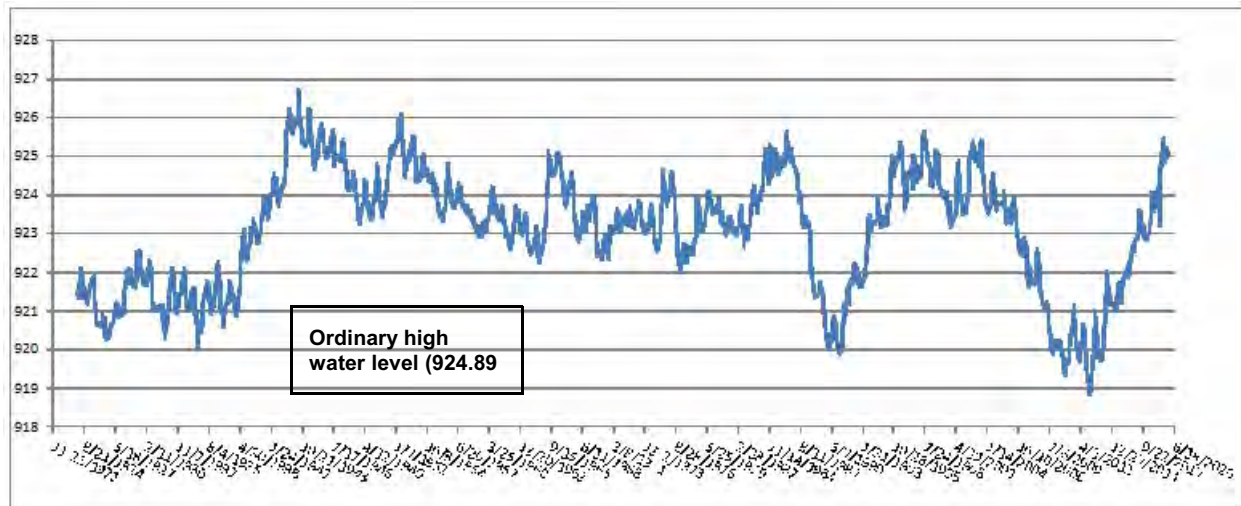
Figure 10. Lake levels for White Bear Lake.

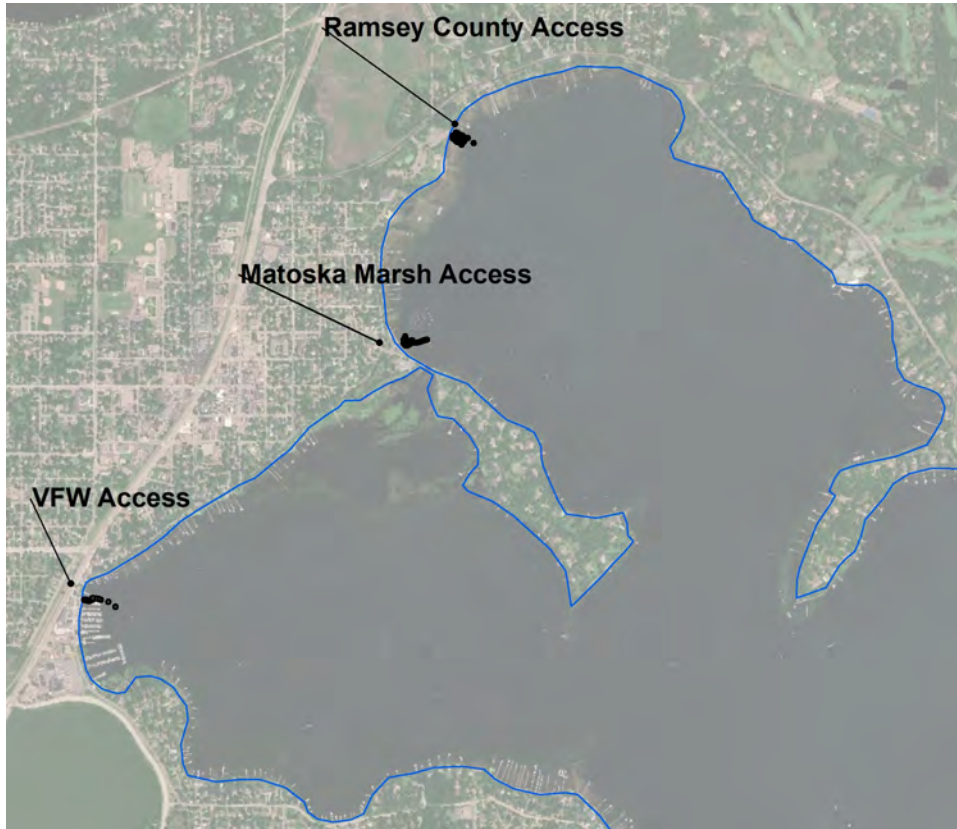
**INVASIVE** Starry stonewort  
*Nitellopsis obtusa*

- Long, smooth branchlets are attached in whorls of 5 – 8
- Small, star-shaped bulks form on clear threads at base of plant and may be found above or below the sediment surface
- Small, orange spheres called antheridia may be visible, these are male reproductive structures
- Typical branchlets are long; can be up to twelve inches
- Can form dense mats in water

Actual size of stonewort  
Below: orange antheridia

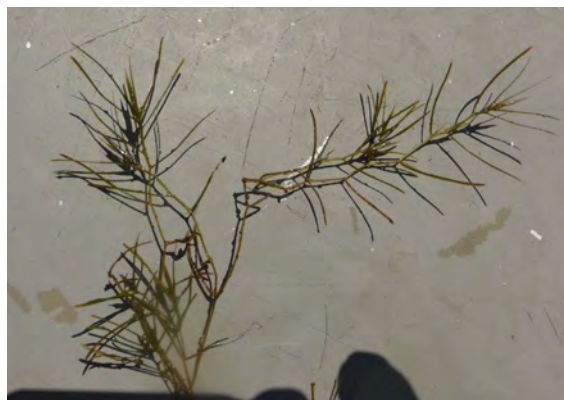
Three accesses were searched for aquatic invasive species including starry stonewort (Figure 11). No new species were observed on August 7, 2019.

Figure 11. [top] Locations around White Bear Lake that were searched for new aquatic invasive species on August 7, 2019. [bottom-left] MAISRC starry stonewort id page. [bottom-right] A native plant found in White Bear Lake that looks a lot like starry stonewort.

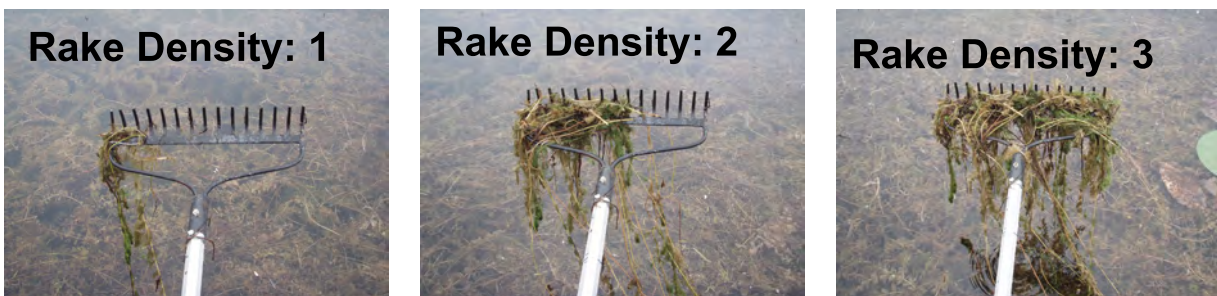
Figure 13. Eurasian watermilfoil rake density ratings from 1 to 3. Native plants used the same rake fullness rating as well.
